VOL 21 NO 5

MAY 2000

The Official Safety Magazine for Army Ground Risk-Management

Investigators' Forum

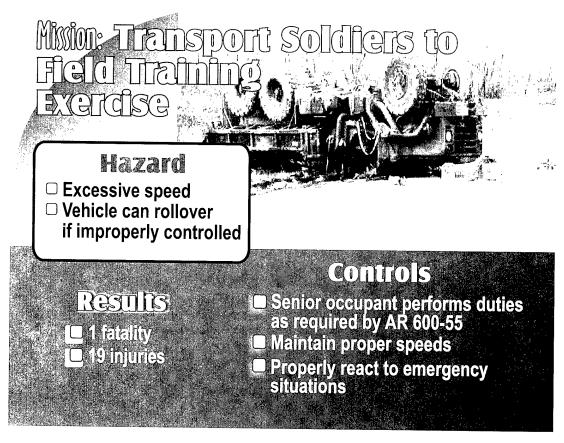
The second lift departed the company area and headed for the training site. The route included a gravel tank trail. As they rounded a corner at about 10 mph over the posted speed limit, the second truck began to fish tail. It swerved to the left side of the road and then returned to the right. At this point, one of the rear wheels left the road and entered a small water-filled ditch. The driver steered to the left to pull the truck out of the ditch. When he did this, the truck overturned. It came to rest on its top, perpendicular to the roadway. The

19 soldiers in the back were injured, some seriously. The driver, who was not wearing his seatbelt, was pinned under the windshield frame and later died from his injuries.

This accident was caused by excessive speed and an improper reaction to an emergency situation. The vehicles were moving too fast on the tank trail. This led to the driver's

loss of control coming out of the curve. He improperly reacted to the departure of his vehicle's right side into the ditch. By oversteering, the vehicle's momentum led to the rollover.

Proper leadership on the part of the platoon leader could have prevented this accident. The senior occupant failed to assume his duties as required by AR 600-55 and other regulations. As a result, no one was in the cab to tell the driver to slow down or to wear his seatbelt.

The vehicles were overloaded. TB 9-369 defines the maximum passenger load in this type of truck is 16. These trucks each had 19 in the rear, with 3 soldiers riding on the baggage between the side rails. These three soldiers were not injured as a result of not being in a seat, but they could have been had the circumstances been different.
